Wiper Motor: All Technical Service Bulletins

Bulletin No.: 02-08-43-002

Windshield Wipers Park In Outwipe Position
(Install Wiper Motor Crank Arm and Wiper Motor Bracket Service Kit)

2002 Buick Century, Regal
2002 Chevrolet Impala, Monte Carlo
2002 Oldsmobile Intrigue
2002 Pontiac Grand Prix

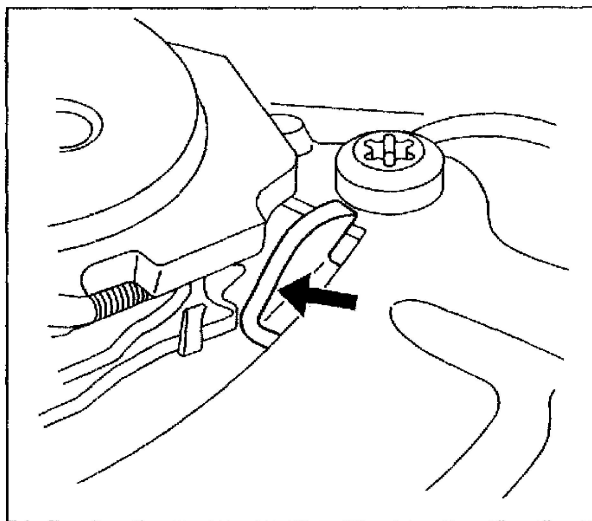
Bent Wiper Motor Park Tab

This condition may be caused by a bent park tab on the windshield wiper motor bracket.

1. Remove the windshield wiper motor drive system module. Inspect the park tab on the wiper motor bracket. It may be bent as shown in the illustration above. Refer to the Wiper Drive System Module Replacement procedure in the Wipers/Washer Systems sub-section of the Service Manual (SI Document ID # 818798).
2. Remove the windshield wiper transmission from the windshield wiper motor bracket. Refer to the Wiper Transmission Replacement procedure in the Wipers/Washer Systems sub-section of the Service Manual (SI Document ID # 818797).
3. Remove the windshield wiper motor crank arm from the windshield wiper motor. Refer to the Wiper Motor Crank Arm Replacement procedure in the Wipers/Washer Systems sub-section of the Service Manual (SI Document ID # 818984).
4. Remove the windshield wiper motor from the windshield wiper motor bracket. Refer to the Wiper Motor Replacement procedure in the

To correct this condition, install a new windshield wiper motor crank arm and a windshield wiper motor bracket service kit. Use the following service procedure:
