2007 ELECTRICAL

Charging System (MZI-3.5) - CX-9

CHARGING SYSTEM LOCATION INDEX [MZI-3.5]

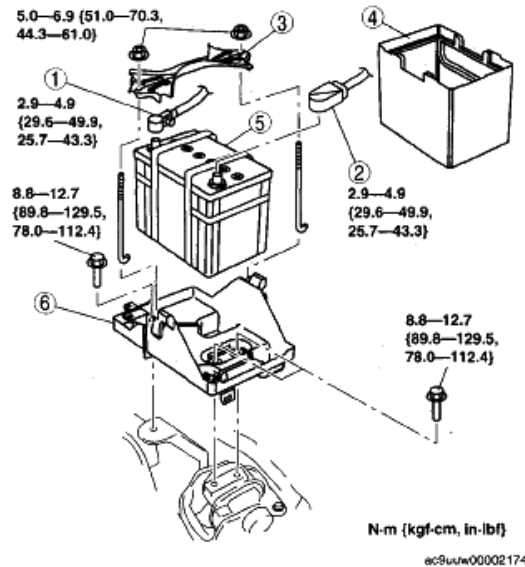
1. Remove in the order indicated in the table.
2. Install in the reverse order of removal.

1	Negative battery cable
2	Positive battery cable
3	Battery clamp
4	Battery box (See Battery Box Installation Note.)
5	Battery
6	Battery tray

Fig. 2: Identifying Battery Components With Torque Specifications
Courtesy of MAZDA MOTORS CORP.

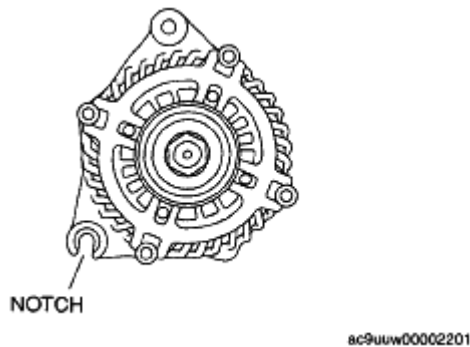
- The generator lower bolt cannot be fully removed from the engine because it contacts the body frame. However, the generator can be removed/installed without fully removing the lower bolt because there is a notch at the lower bolt installation part of the generator.

1. Fully loosen the generator lower bolt.

Fig. 6: Identifying Generator Lower Bolt
Courtesy of MAZDA MOTORS CORP.
