2008 ENGINE PERFORMANCE On-Board Diagnostic (MZI-3.7) - Mazda CX-9

ON-BOARD DIAGNOSTIC WIRING DIAGRAM [MZI-3.7]

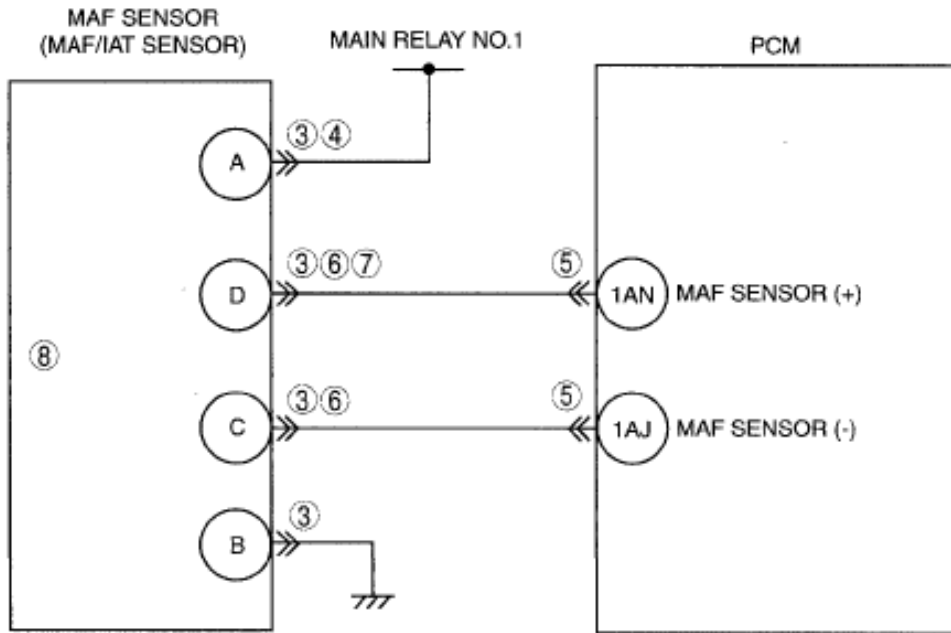
PCM WIRING HARNESS-SIDE CONNECTOR

MAF/IAT SENSOR MAIN RELAY NO.1 WIRING HARNESS-SIDE CONNECTOR

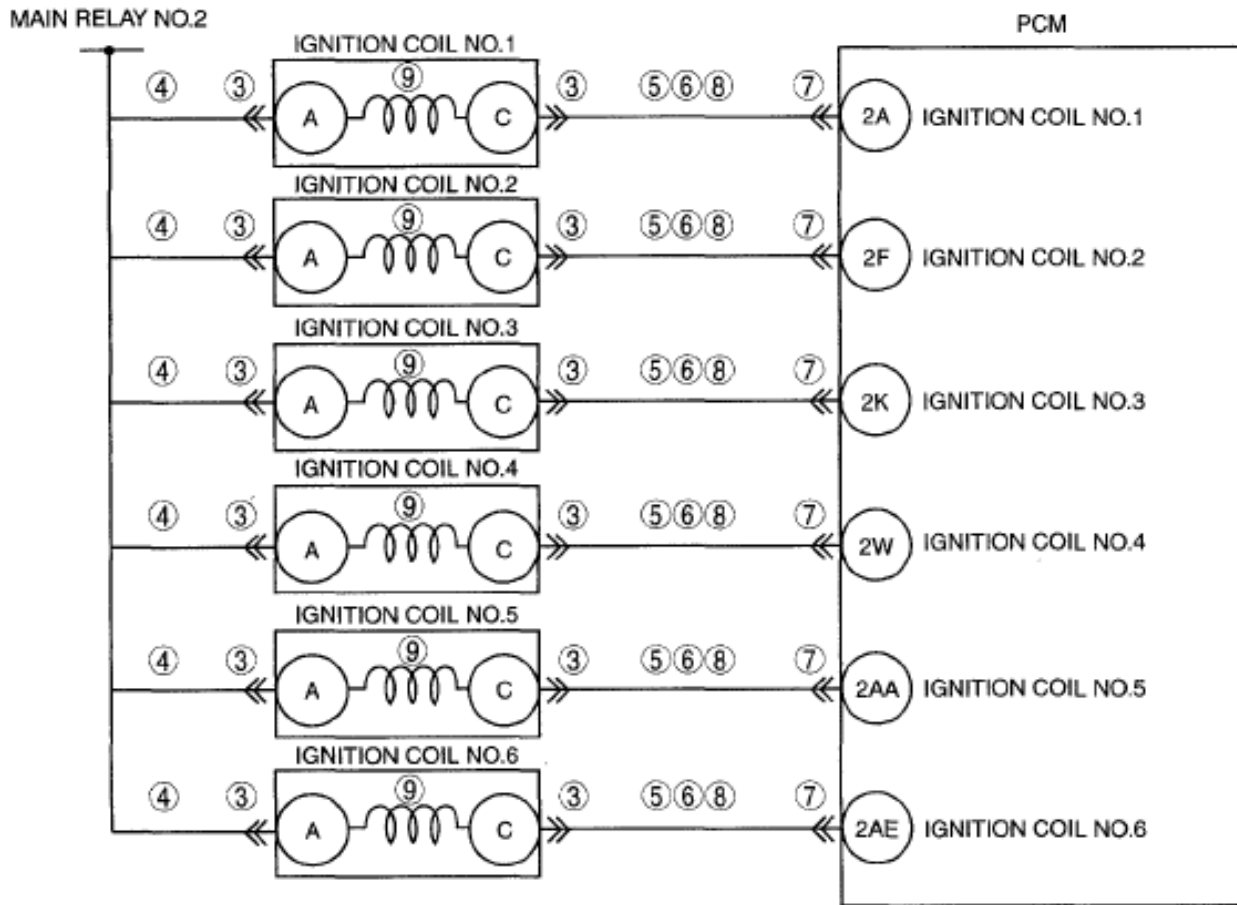
IGNITION COIL NO.1—NO.6
MAIN RELAY NO.2 WIRING HARNESS-SIDE CONNECTOR

PCM
WIRING HARNESS-SIDE CONNECTOR

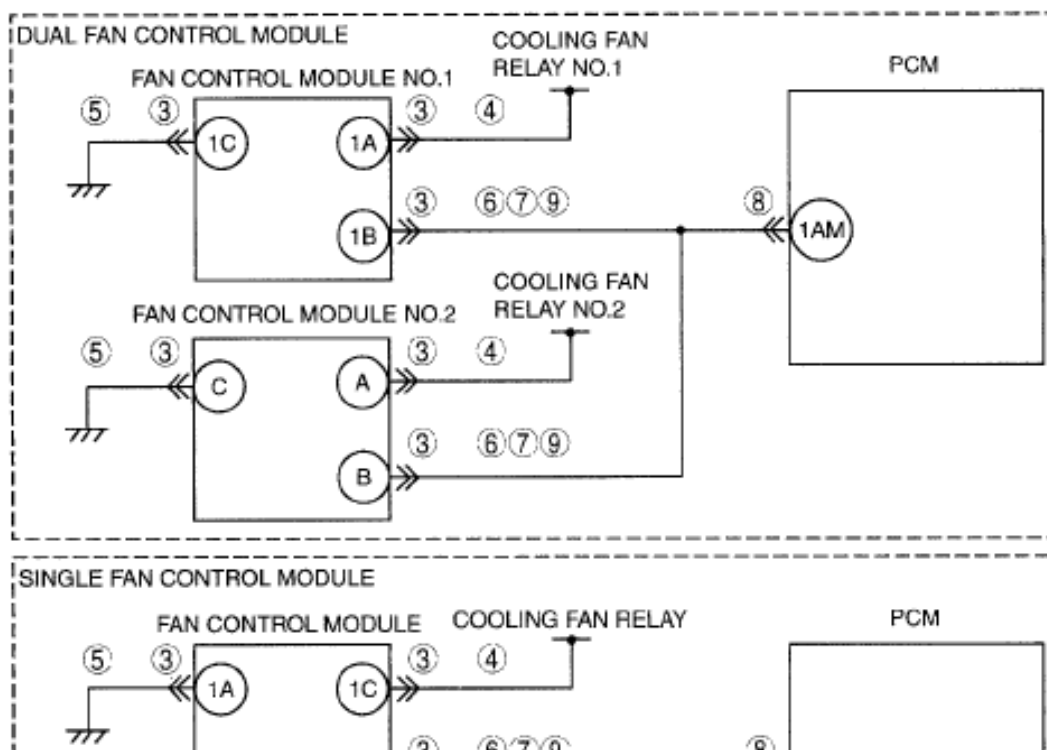
- Open circuit between fan control module terminal 1C and cooling fan relay terminal E
- Open circuit between fan control module terminal 1A and body ground

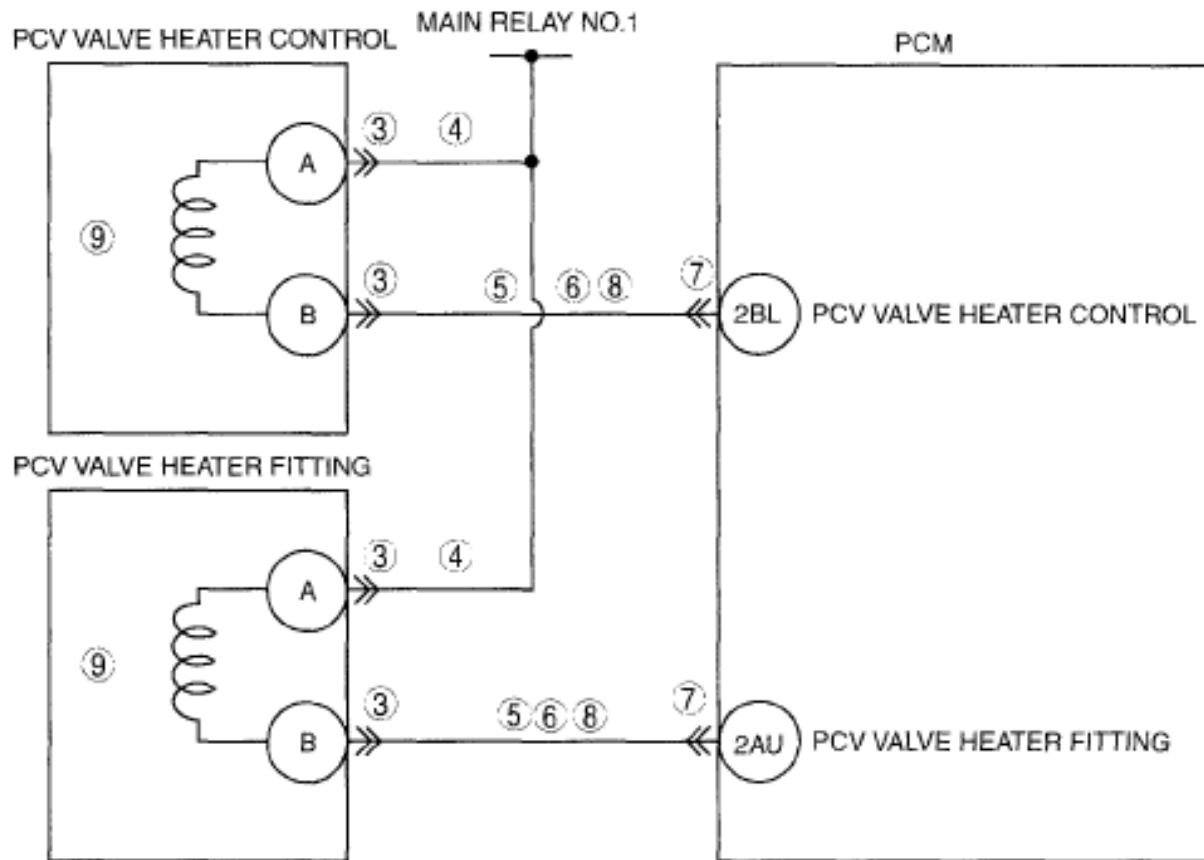
PCV VALVE HEATER CONTROL WIRING HARNESS-SIDE CONNECTOR

PCM WIRING HARNESS-SIDE CONNECTOR
