2008 Mazda CX-9 Grand Touring

2008 BODY & ACCESSORIES Symptom Troubleshooting (Car Navigation System) - Mazda CX-9

CAR-NAVIGATION SYSTEM [CAR-NAVIGATION SYSTEM]

TROUBLESHOOTING INDEX

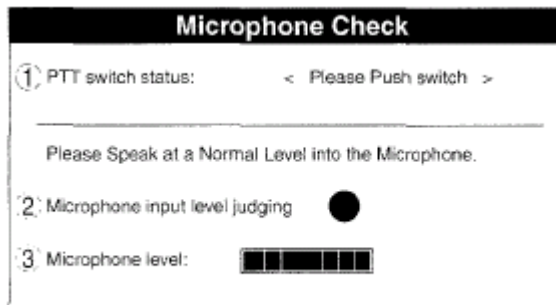
Microphone related signal inspection:

1. Press the "Menu" button on the "Diagnosis Check" screen.
2. Select "Navigation Check Menu".
3. Select "Microphone Check".

Fig. 3: Diagnosis Check Screen Display - Microphone Check
 Courtesy of MAZDA MOTORS CORP.

MICROPHONE CHECK INSPECTION CHART

No.	Display item	Description
1	PTT switch status	Indicates the status of the VOICE button. <ul style="list-style-type: none"> • < OK >: Press the button (Keep the state until the screen is changed.) • < Please Push Switch >: Other than above condition.
		Indicates the test results.
