2008 BODY & ACCESSORIES

On-Board Diagnostic (Power Liftgate (PLG) System) - Mazda CX-9

FOREWORD [POWER LIFTGATE (PLG) SYSTEM]

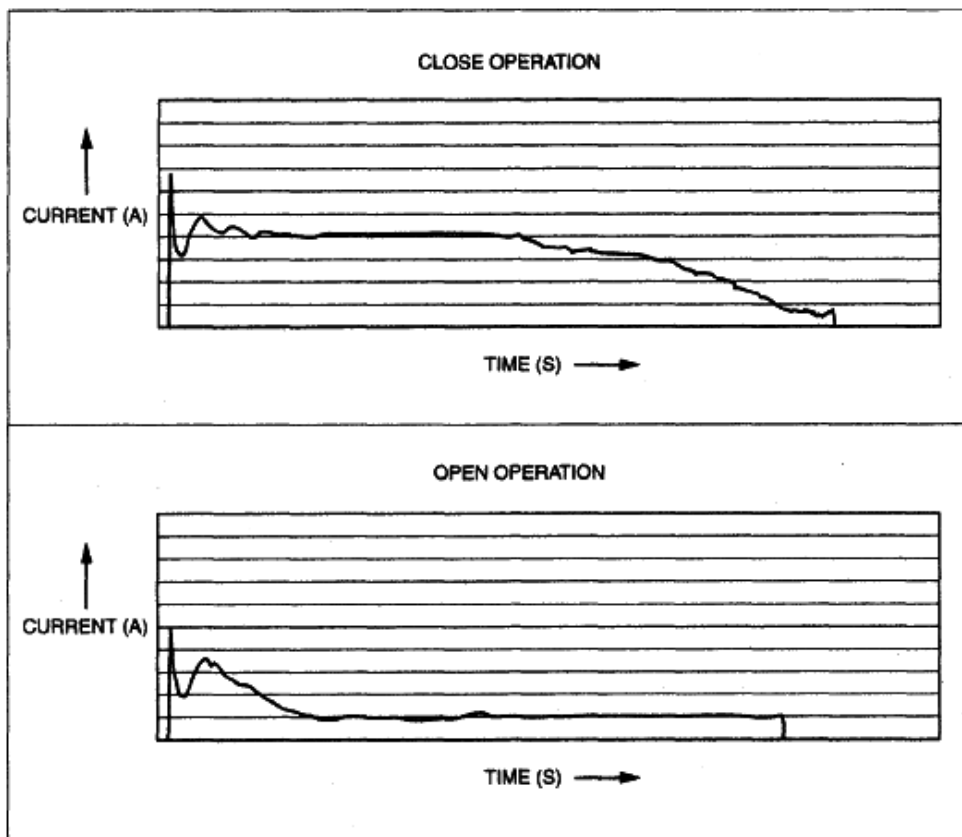
Fig. 5: Current Flow Graph
Courtesy of MAZDA MOTORS CORP.
